慶長伏見地震と洲本城

The Great Earthquake and Sumoto Castle

洲本市

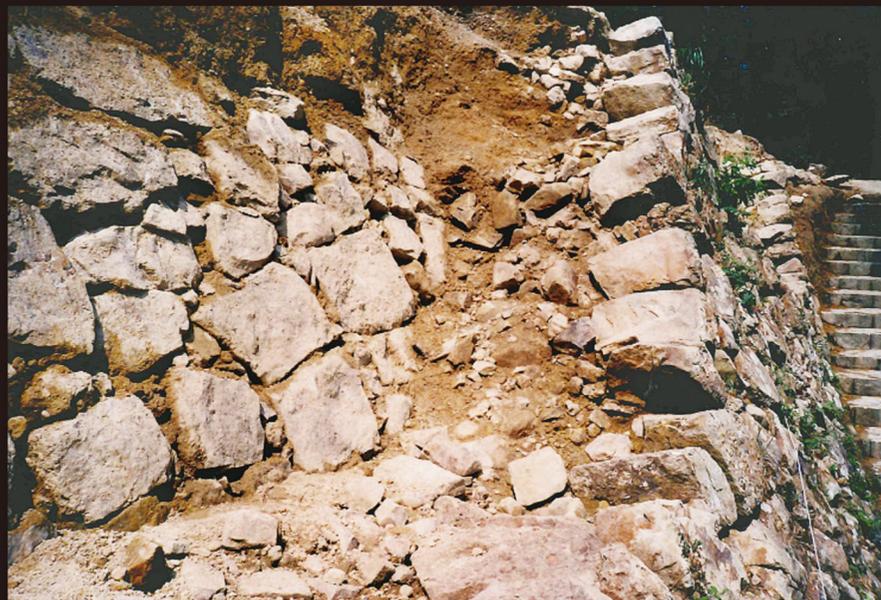
東の丸水の手郭石垣は、平成12年(2000年)に修理のため解体した際、背面から古い石垣が出てきました。慶長伏見地震により崩落した石垣をそのままにして、前面に新たに石垣を築いたと考えられます。

When the stone walls of the Mizu-no-te-kuruwa (Water Supply Bailey) in the Eastern Bailey were dismantled for repairs in 2000 (the 12th year of the Heisei era), an older stone wall was discovered behind them. This suggests that after the original walls collapsed in the Keichō Fushimi Earthquake, they were left in place and a new wall was constructed in front of them.

石垣解体中に出土した石垣 1

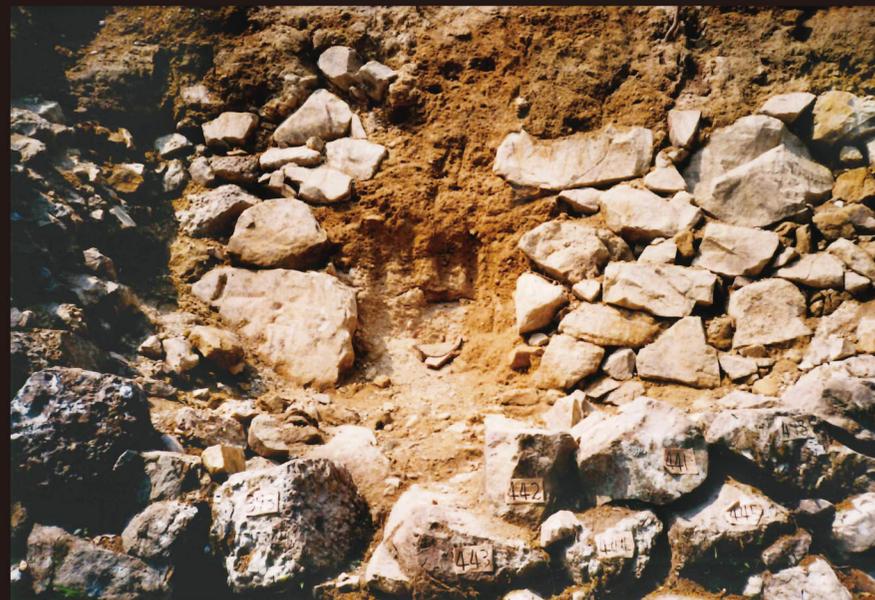
石垣解体中に出土した石垣 2

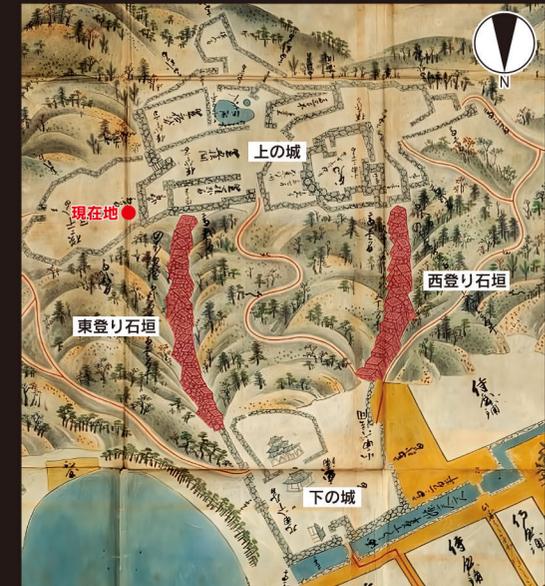
洲本城には、山上の城(上の城)と山麓の城(下の城)を結ぶ東西2条の石垣があります。これは、「登り石垣」と呼ばれ、上下の城を結び、城をより強固にするものと言われています。

Sumoto Castle has two stone wall structures running east and west that connect the Upper Castle on the mountaintop with the Lower Castle at the foot of the mountain. These are known as nobori-ishigaki ("climbing stone walls"), and they are said to have linked the two castles while reinforcing the castle's defenses.

登り石垣の図

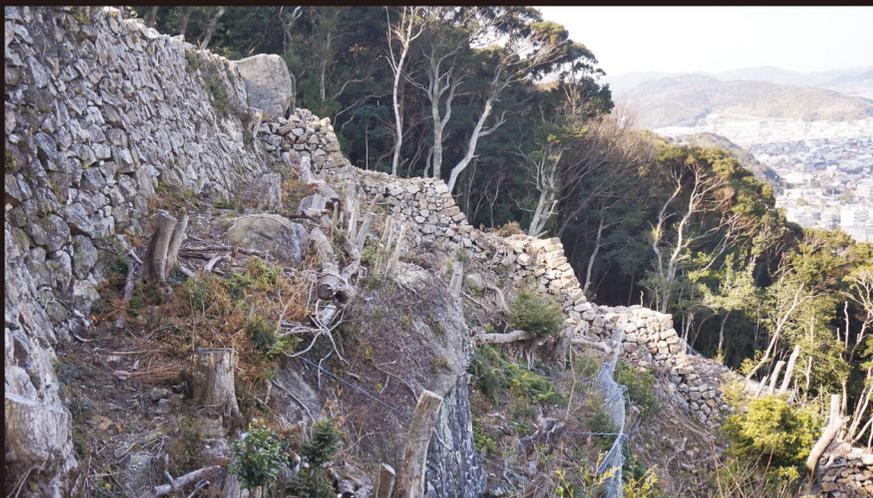
洲本城の登り石垣は、急傾斜地に階段状に積まれているのが特徴です。また東登り石垣の外(東)側には、豎堀が築かれており、登り石垣をより効果的にする工夫が施されています。

A distinctive feature of Sumoto Castle's climbing stone walls is that they are constructed in a stepped pattern along steep slopes. In addition, on the outer (eastern) side of the eastern climbing stone wall, a vertical moat (tatebori) was built, an innovation that further enhanced the defensive effectiveness of the walls.

階段状の東登り石垣

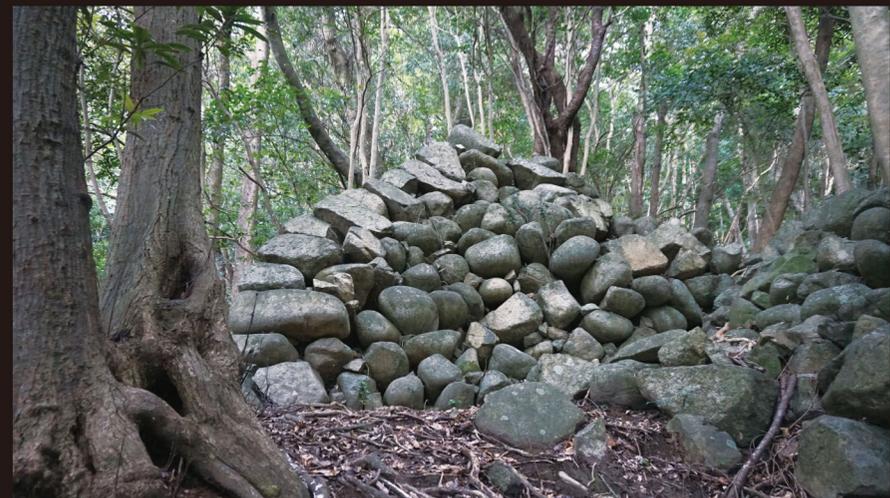
花崗岩で積まれた石垣(東登り石垣中腹)

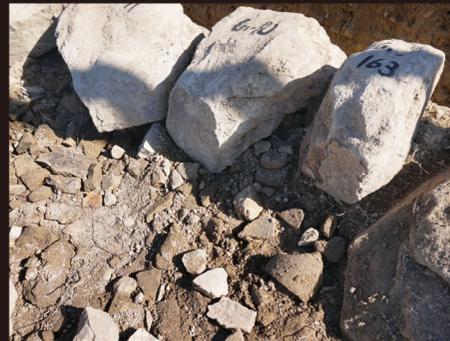
石墨内部を確認すると、多量の瓦が出土しました。通常石垣の内部は栗石が詰められていますが、石墨内部にのみ瓦が多量に入れられていました。この内部の瓦は、周辺から出土している瓦より少し古いことから、慶長伏見地震により倒壊した建物に伴うものと考えられています。瓦の中には、文字瓦も確認され「識房」「老僧」など寺院関係の文字が多く、中には「天正九年」銘の丸瓦も出土しています。

石墨内部の瓦の出土状況

Upon examining the inside of the embankment, a large quantity of roof tiles was discovered. Normally, the interior of stone walls is filled with rubble stones, but in this case, only the embankment contained an abundance of tiles. Since these tiles are slightly older than those unearthed from the surrounding area, they are believed to have originated from buildings that collapsed during the Keichō Fushimi earthquake. Among the tiles, inscribed pieces were found, written characters such as "Shikibō" and "Rōsō," terms related to temples. Notably, a round tile inscribed with the era name "Tenshō 9" (1581) was also excavated.

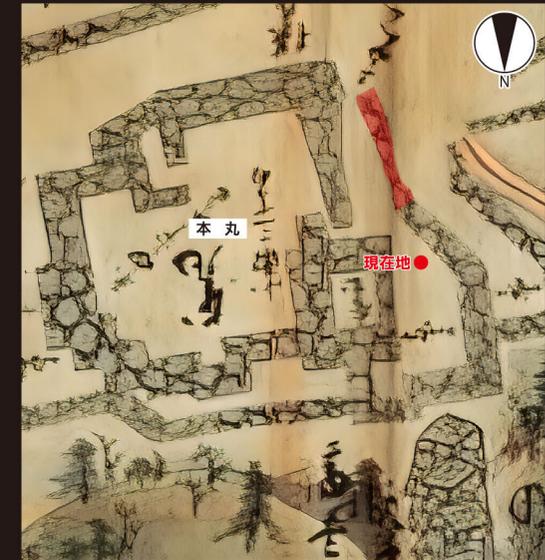
本丸搦手西側石垣の積直しに伴う発掘調査で、長さ約20.0m、高さ約1.5mの石墨が確認されました。搦手口を守るために防御を厚くしたものと思われます。

本丸搦手西側石垣

During the recent excavation survey in connection with the rebuilding of the stone wall on the west side of the Honmaru's rear entrance (karameteguchi), a stone embankment measuring approximately 20.0 meters in length and 1.5 meters in height was discovered. It is thought that this structure was built to reinforce defenses protecting the rear gate.

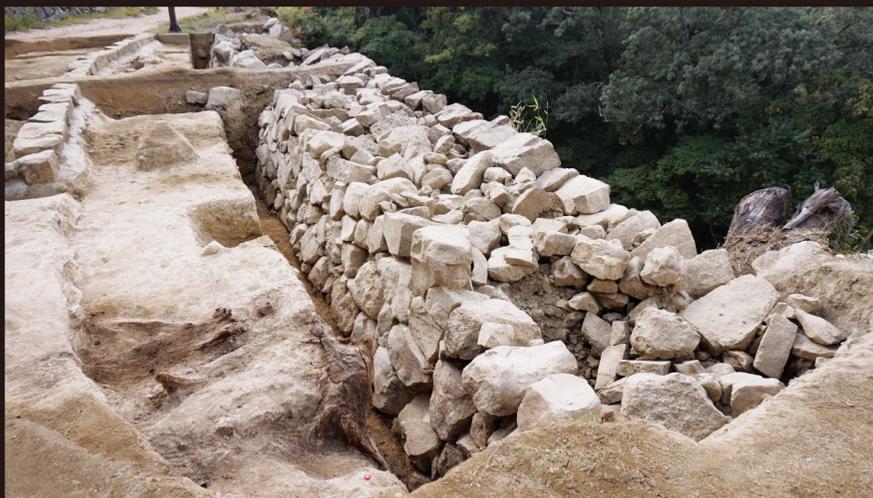
石墨(出土時の様子)1

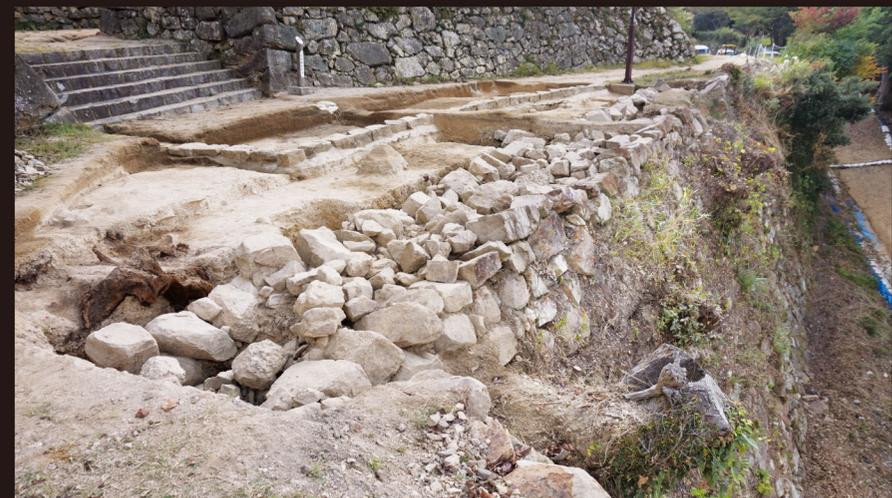
石墨(出土時の様子)2

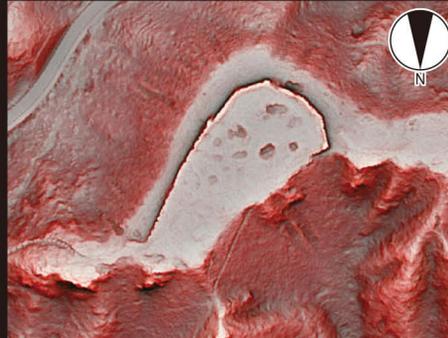
西の丸には、曲輪の中央部に複数の穴があります。これは、石材を切り出した際の穴でこの場所が石切場であったことがわかります。石を切り出す際、矢穴と呼ばれる穴を開け、そこに楔を打ち込み、石を割ります。

石切りの穴(赤色立体図)

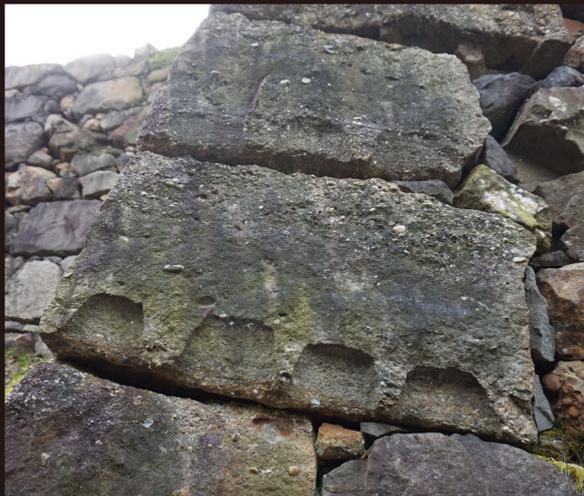
洲本城の石垣には、この矢穴が残る築石が確認できます。また、矢穴をあけながら築石として使用されなかった「残念石」が西の丸に2箇所残っています。

Some of building stones used in the stone castle walls of Sumoto Castle still retain these bore hole. In addition, two “disappointing stones” (zannen-ishi)—blocks that were drilled with bore hole but never used as building stones—remain in the Nishi-no-maru.

矢穴が入った築石

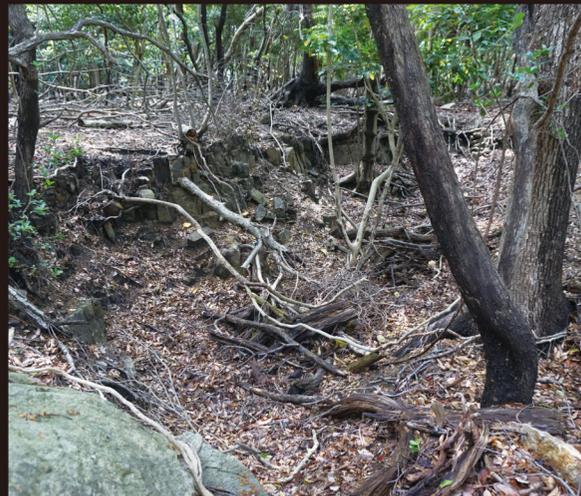
石切場跡

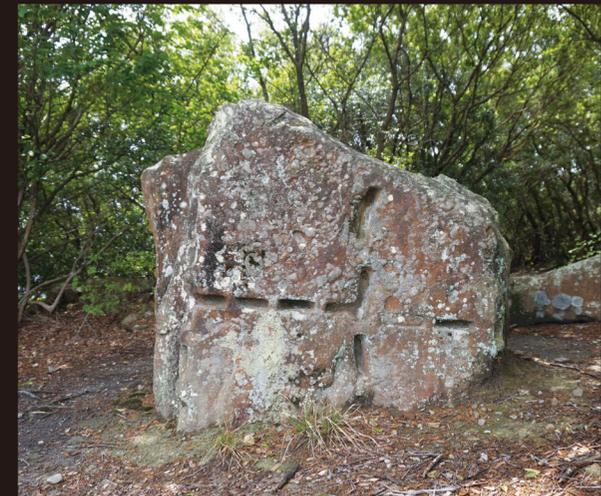
残念石(十字に矢穴が残る)
